CINCINNATI FIRE DEPARTMENT
FAO DARYL GORDON LINE OF DUTY DEATH
PRELIMINARY REPORT

August 9, 2015

The following report is a product of the Dahlgren Investigative Work Group. The work group and the Dahlgren Investigative Committee were formed to ensure that all factors leading to the death of Fire Apparatus Operator (FAO) Daryl Gordon would be fully investigated so that appropriate actions may be taken to lessen the chance of a similar occurrence. The information contained in this report has been compiled using data obtained from members' SCBA Integrated Control Modules (ICM), Motorola radio transmission data, and interviews conducted in conjunction with the National Institute of Occupational Safety and Health (NIOSH), as well as the investigative efforts of work group members. This preliminary report contains the facts surrounding the LODD of FAO Gordon, and primarily focuses on the event timeline of the multiple alarm fire at 6020 Dahlgren Street on March 26, 2015.

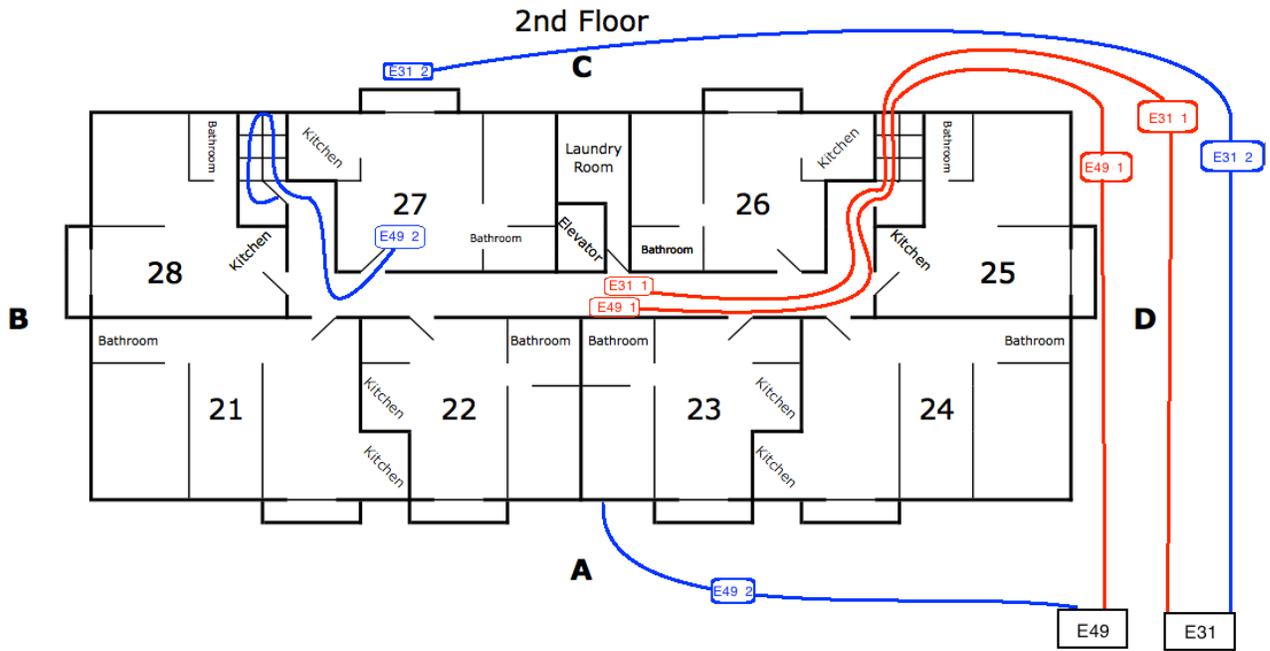
Figure 7: Hose deployment

NOTE: The second line off of Engine 49 [E49 2] was advanced through the first floor A side entrance and up the B-C stairwell to the second floor.
